FINAL REPORT

**A STUDY OF HYDROGEN EMBRITTLEMENT
OF VARIOUS ALLOYS**

**NATIONAL AERONAUTICS AND SPACE
ADMINISTRATION
GEORGE C. MARSHALL
SPACE FLIGHT CENTER**

T. P. Groeneveld, E. E. Fletcher, and A. R. Elsea

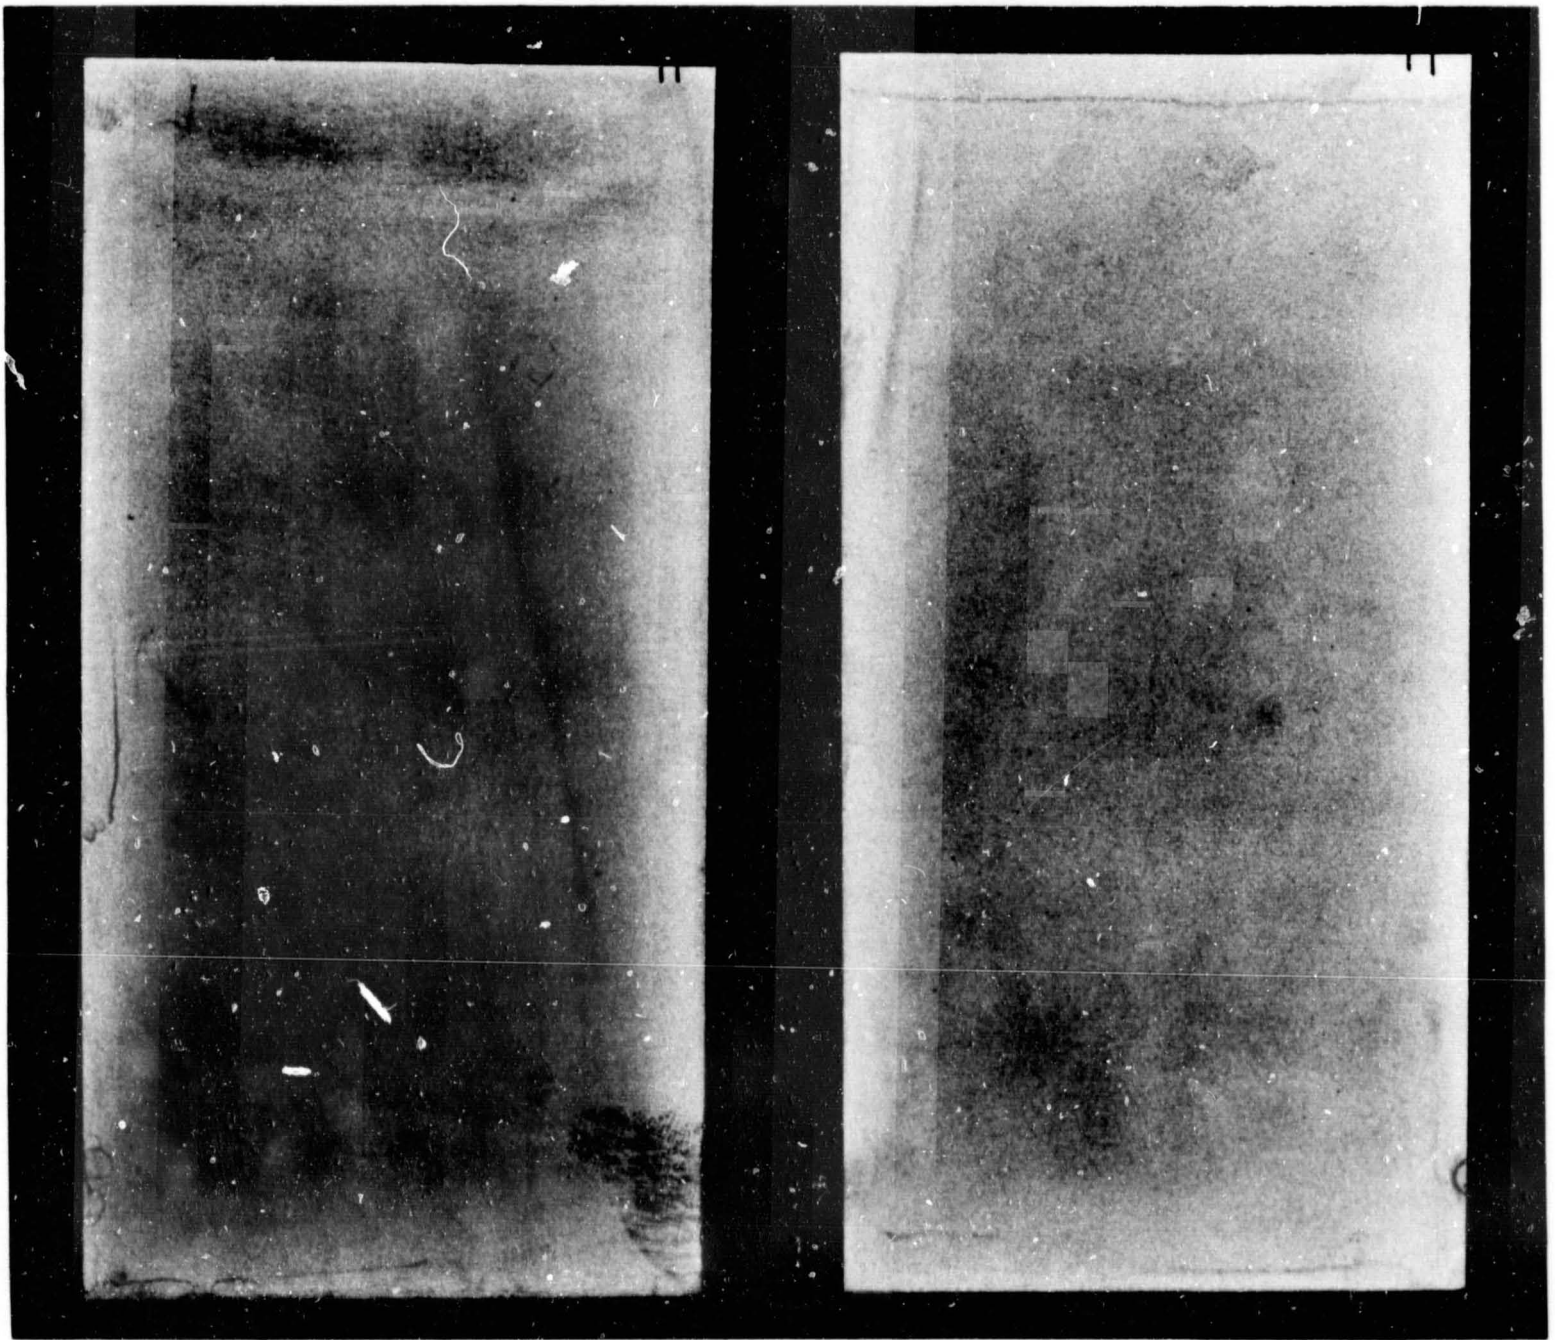
FIGURE 20. WATTS-NICKEL-ELECTROPLATED PANELS PRIOR
TO EXPOSURE TO SALT SPRAY

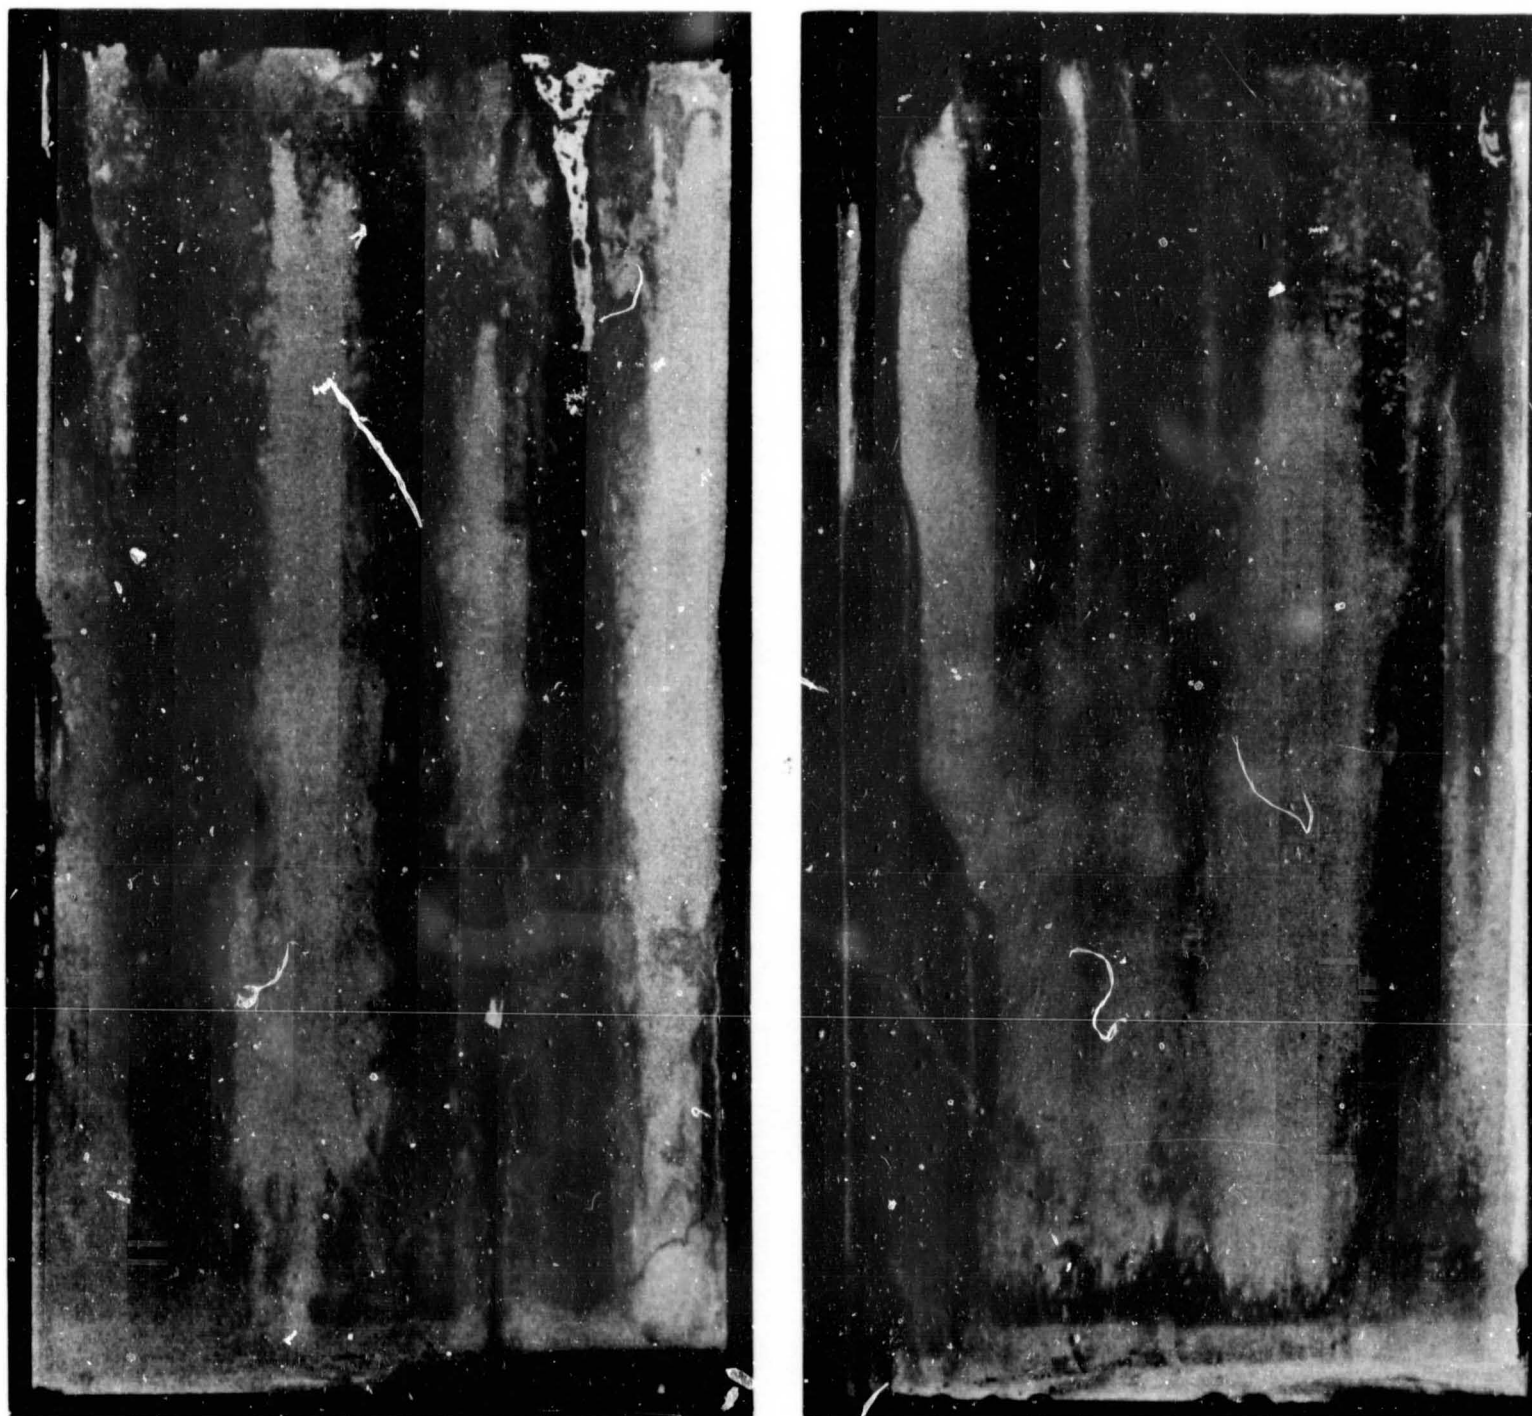
FIGURE 21. WATTS-NICKEL-ELECTROPLATED PANELS AFTER 240-HOUR EXPOSURE TO SALT SPRAY

As is shown in Figure 21, the Watts-nickel electroplate failed to protect the base steel from corrosion. Evidence of corrosion of the steel was observed on both panels after 24 hours of exposure, and the corroded areas became more extensive as the exposure time increased.

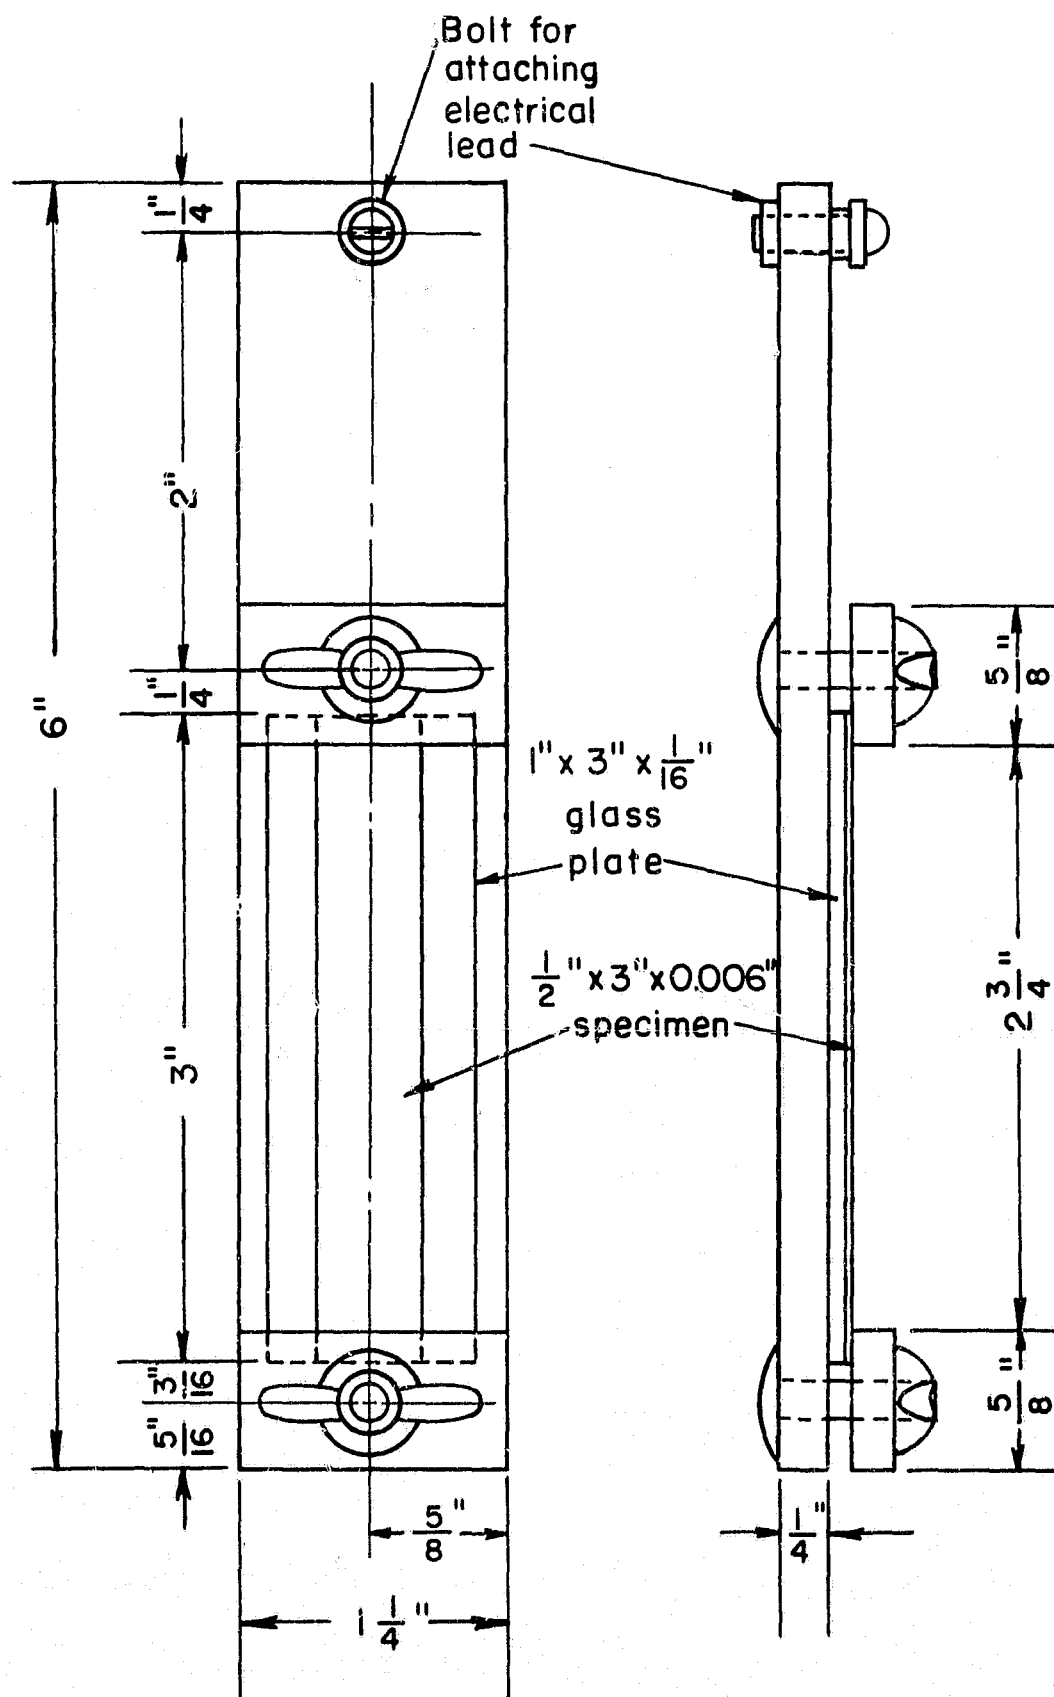
FIGURE 22. FIXTURE USED TO HOLD STRIP SPECIMENS DURING ELECTROPLATING

All exposed surfaces of fixture stopped off with electrical insulating coating.

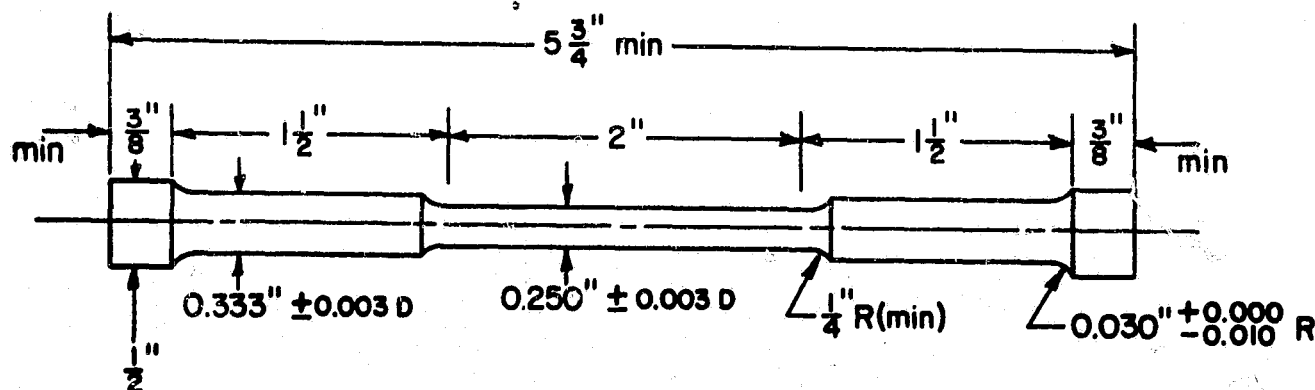
FIGURE 24. DETAILS OF THE SPECIMEN USED TO VERIFY THE TENSILE PROPERTIES OF THE HEAT-TREATED SPECIMENS

Two of these blanks were then machined into smooth (unnotched) specimens according to the dimensions shown in Figure 24. These specimens were pulled to failure in a tensile-testing machine at a platen speed of 0.02 inch per minute. The tensile properties of these specimens are listed in Table 25.
